Influence of Geology on shaking levels during the 1989 LPE:

Visual 7.3

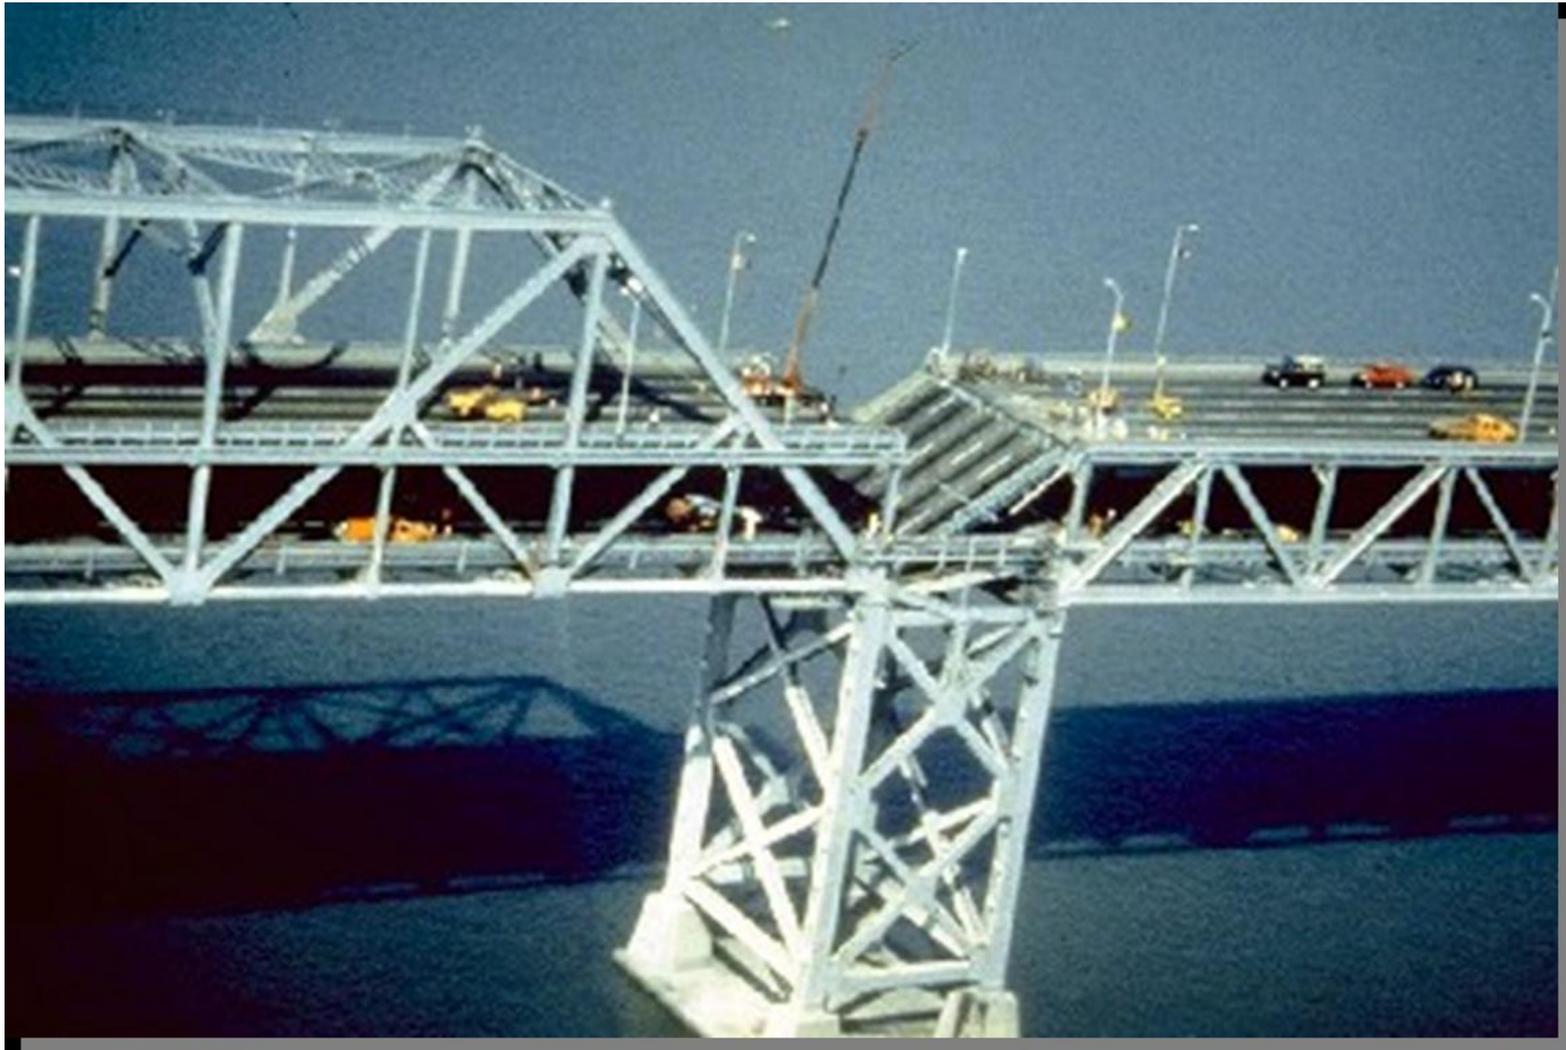
Moderate Failure, Severe Disruption

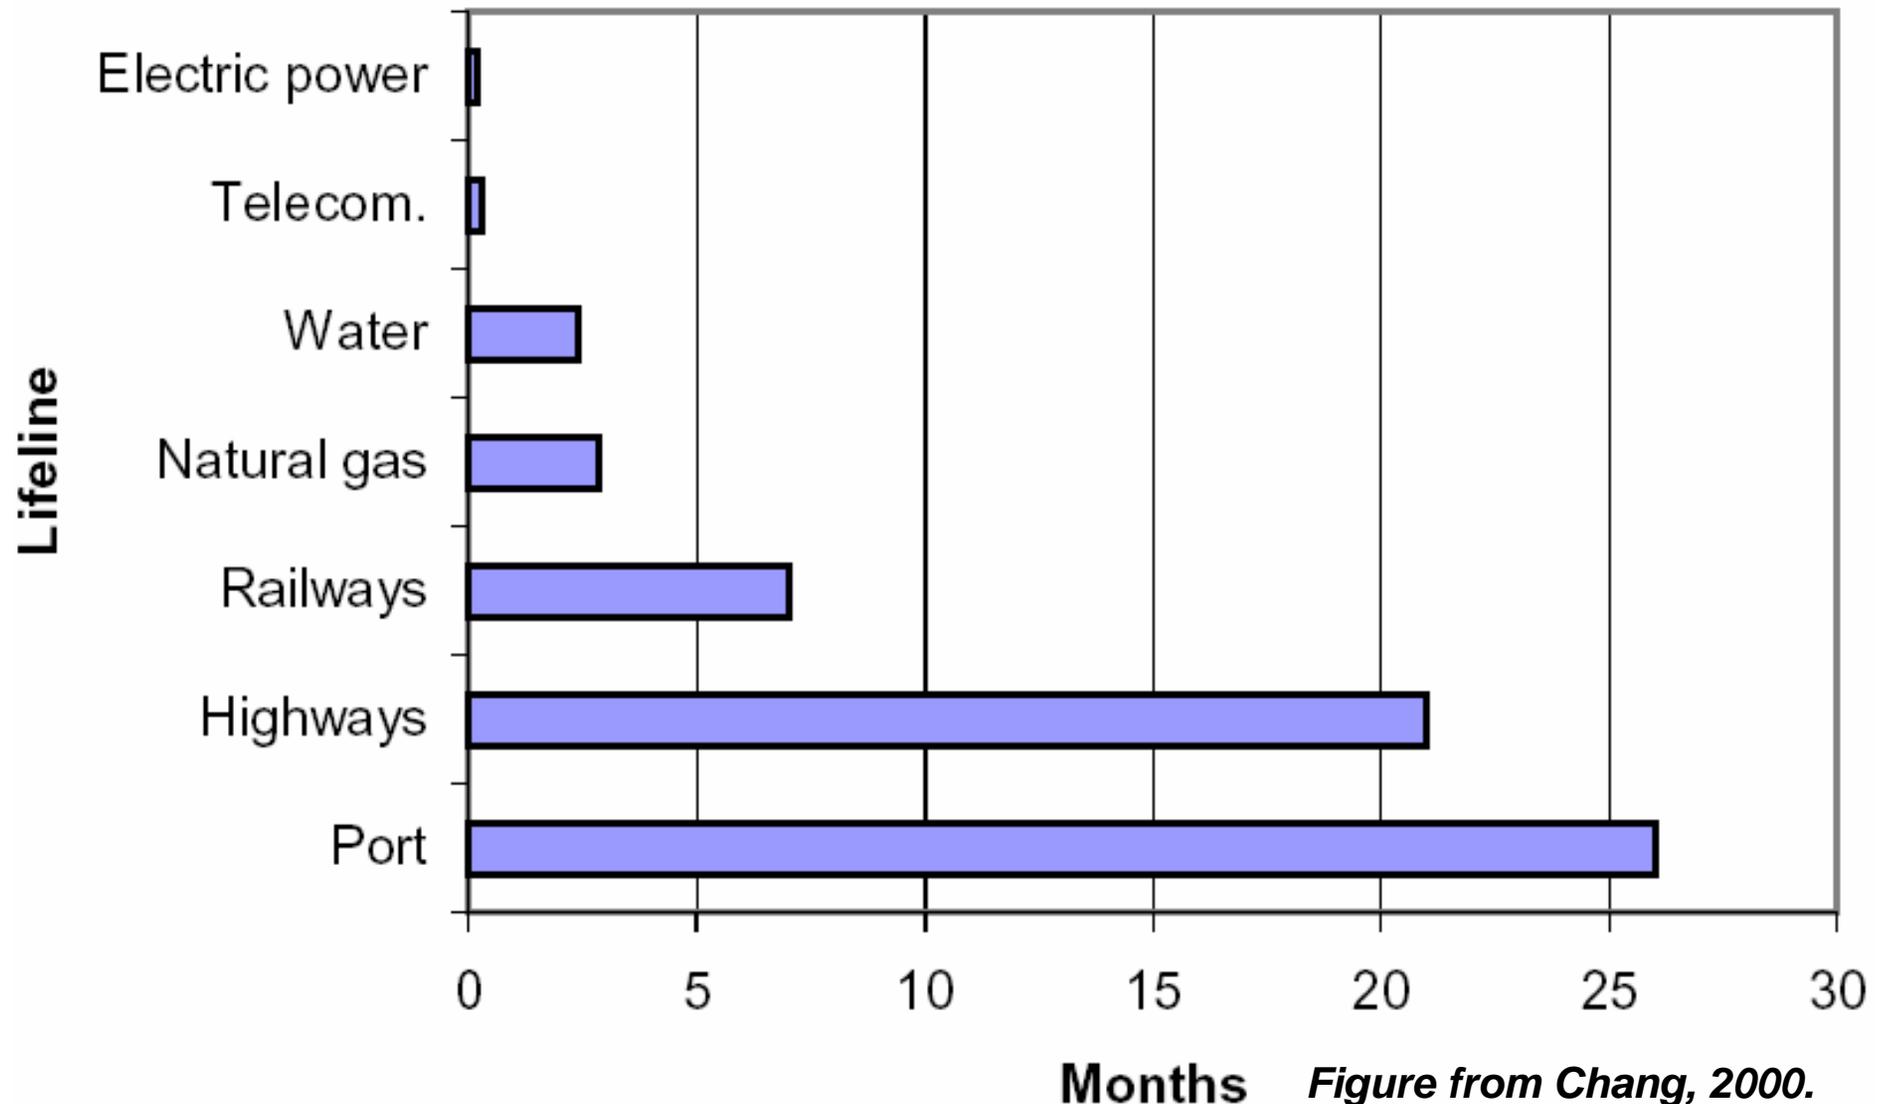
Time Required for Lifeline Restoration Following the 1995 Kobe, Japan EQ

Months *Figure from Chang, 2000.*

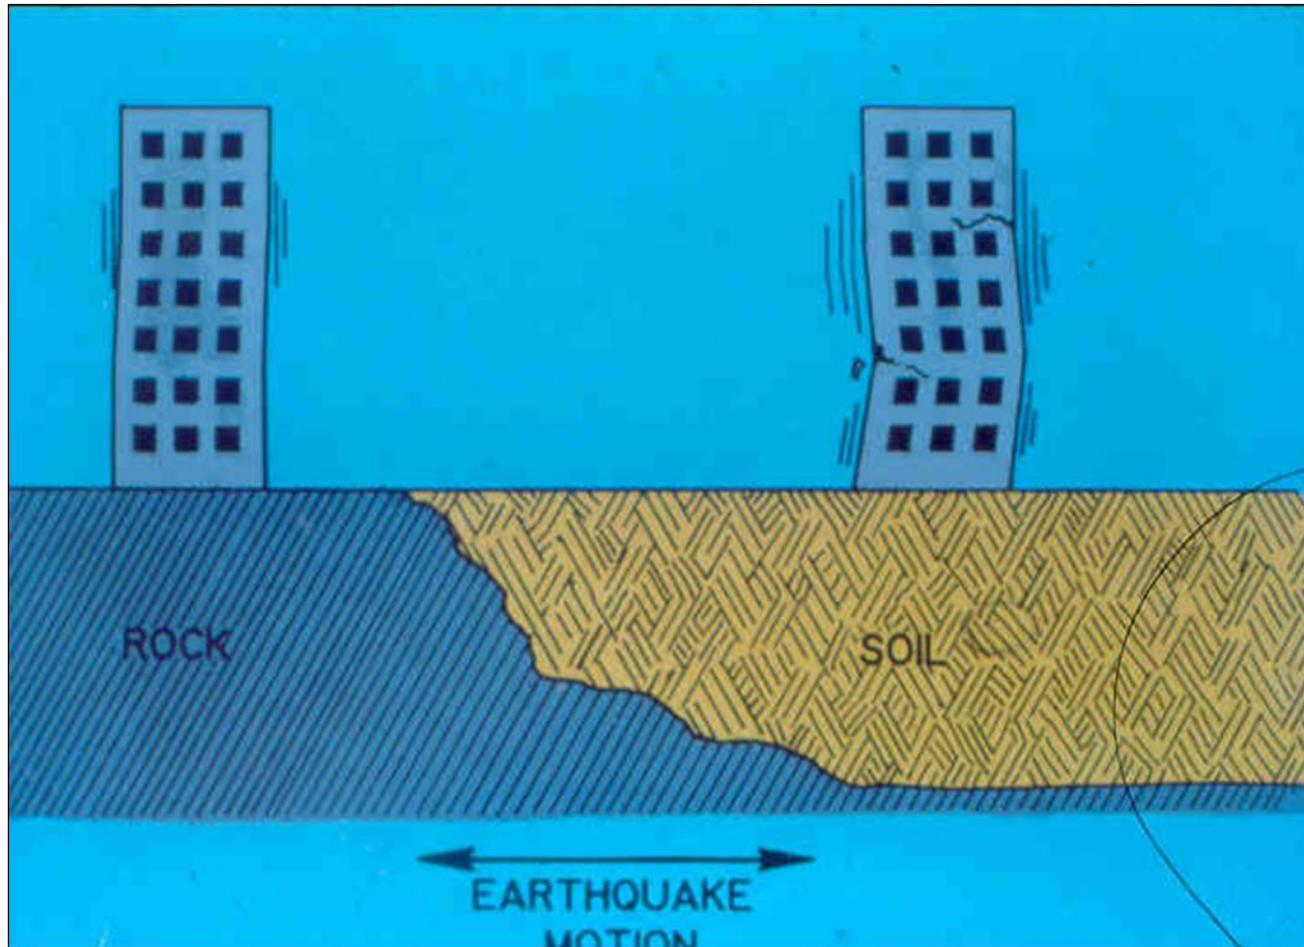
Stronger shaking on softer sites

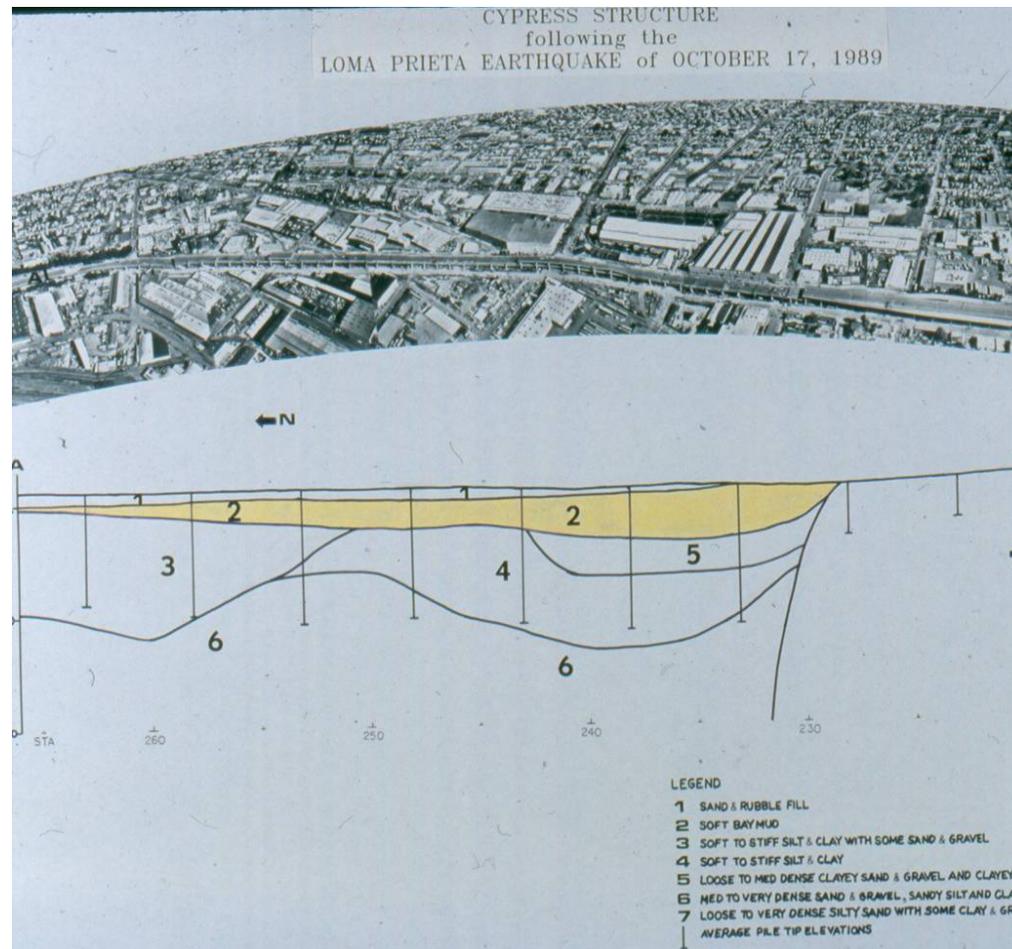
Influence of soft sediments

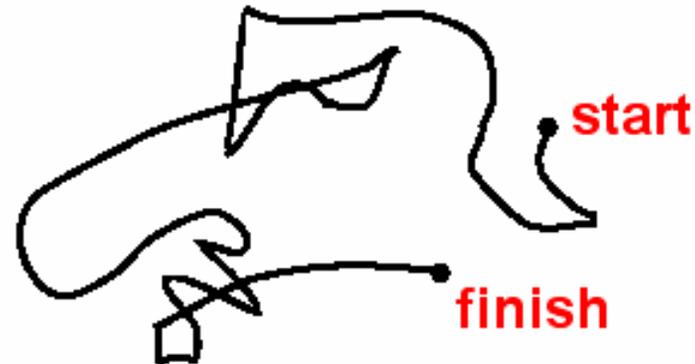
Ground shakes erratically

MOTION AT A SITE

scratch left on the floor
by a kitchen range in the 1933
Long Beach, California earthquake.

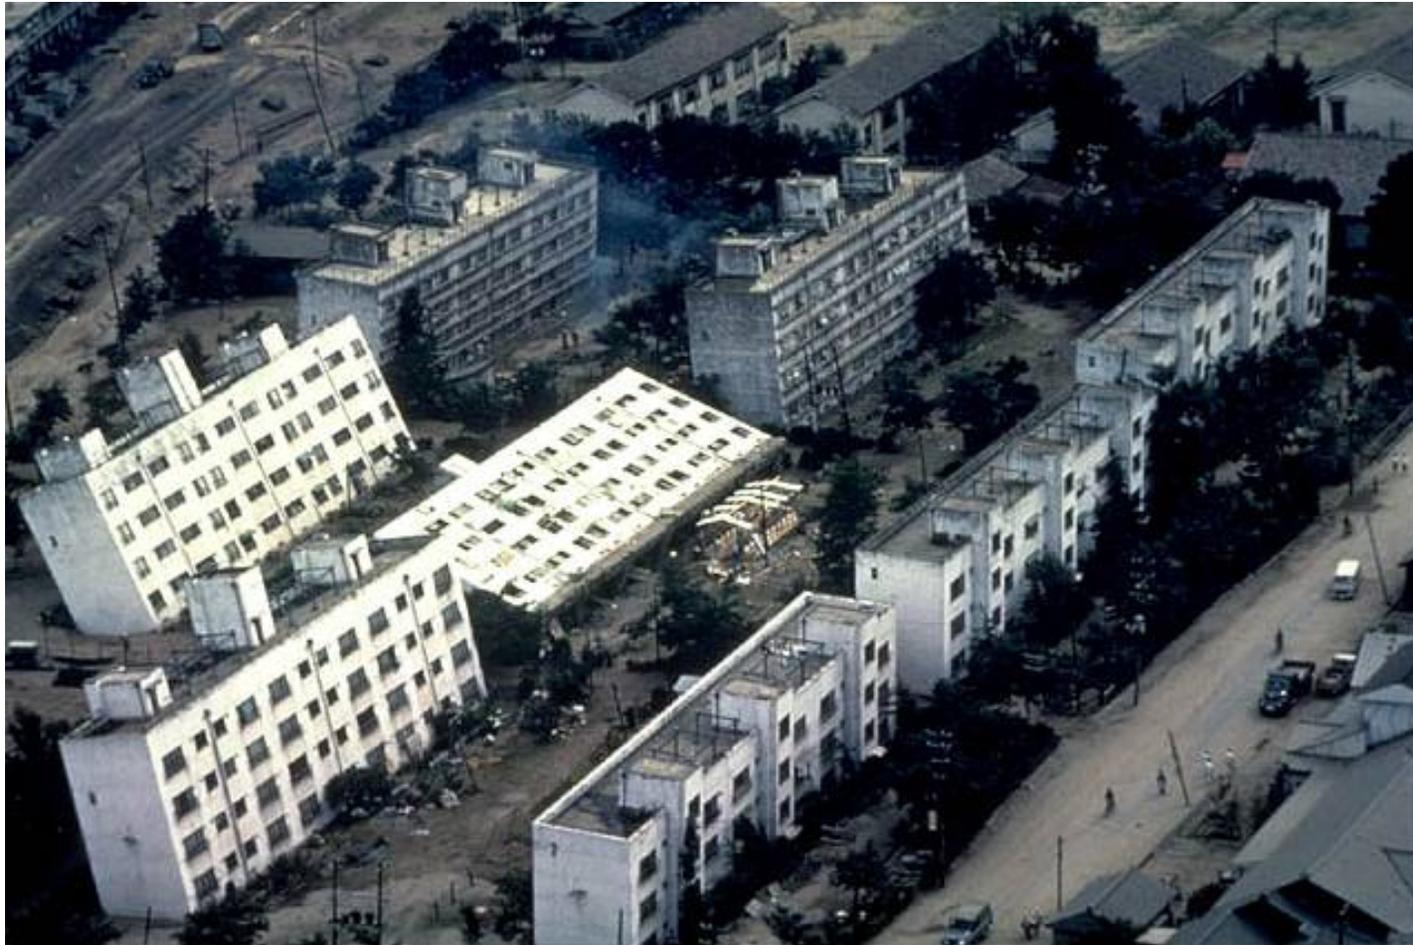
Liquefaction damages infrastructure

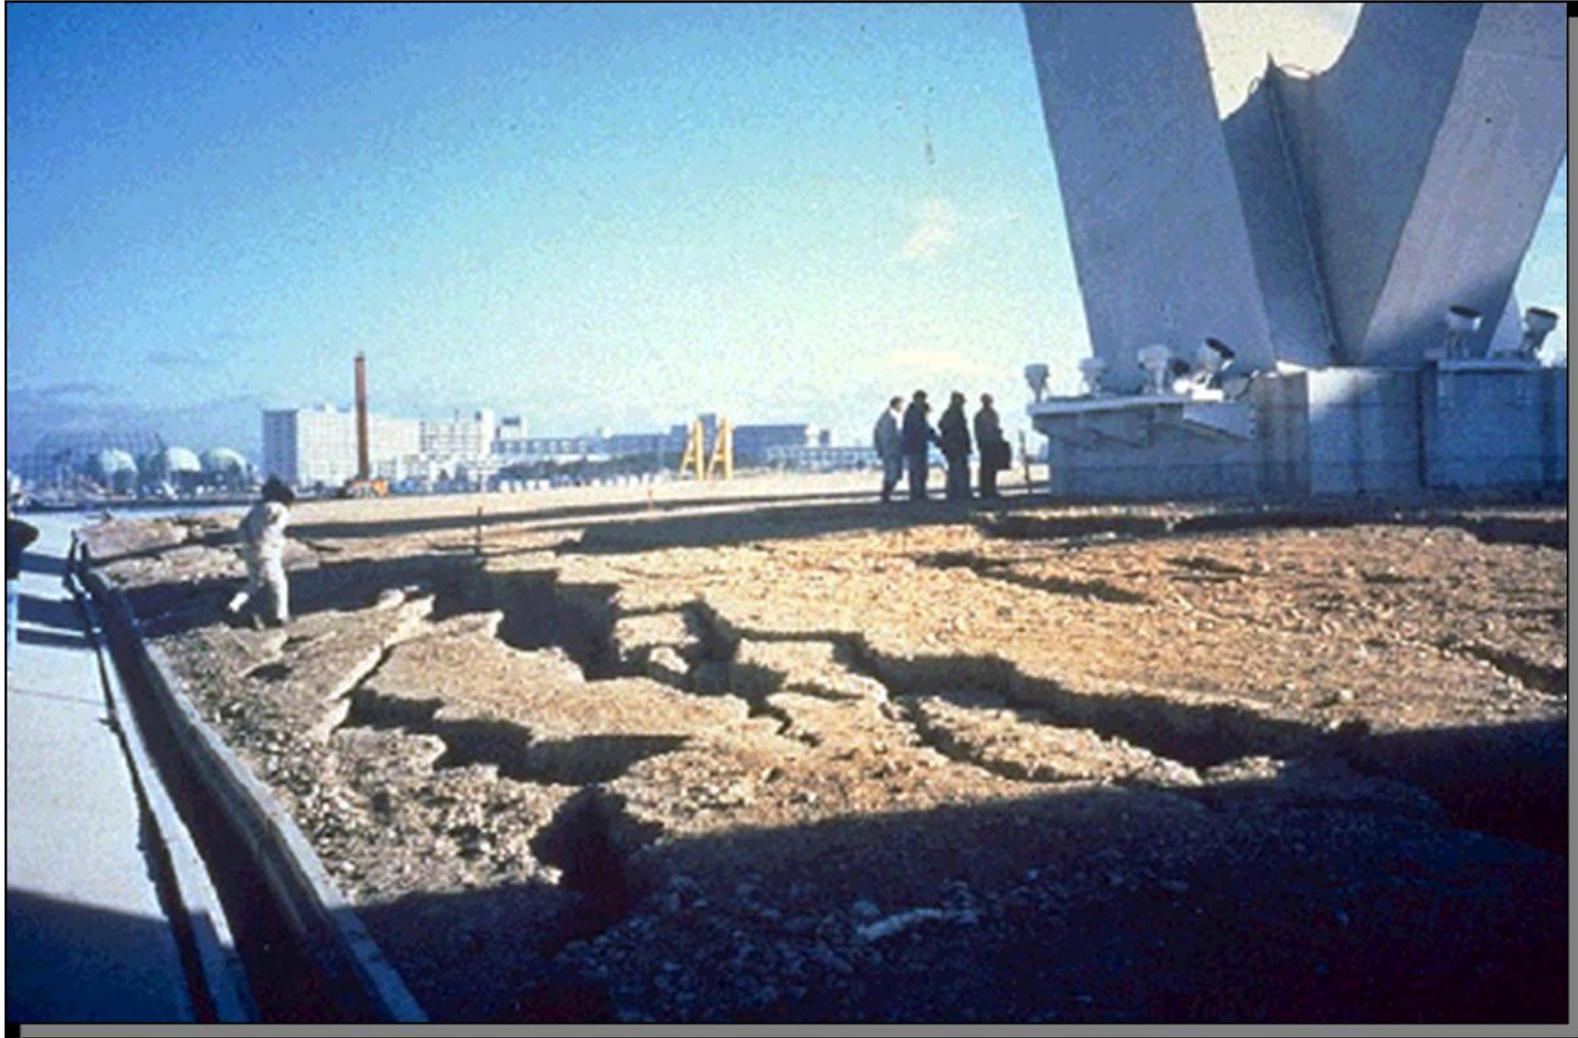
Liquefaction and Lateral Spreading at Port 1995 Kobe, Japan Earthquake

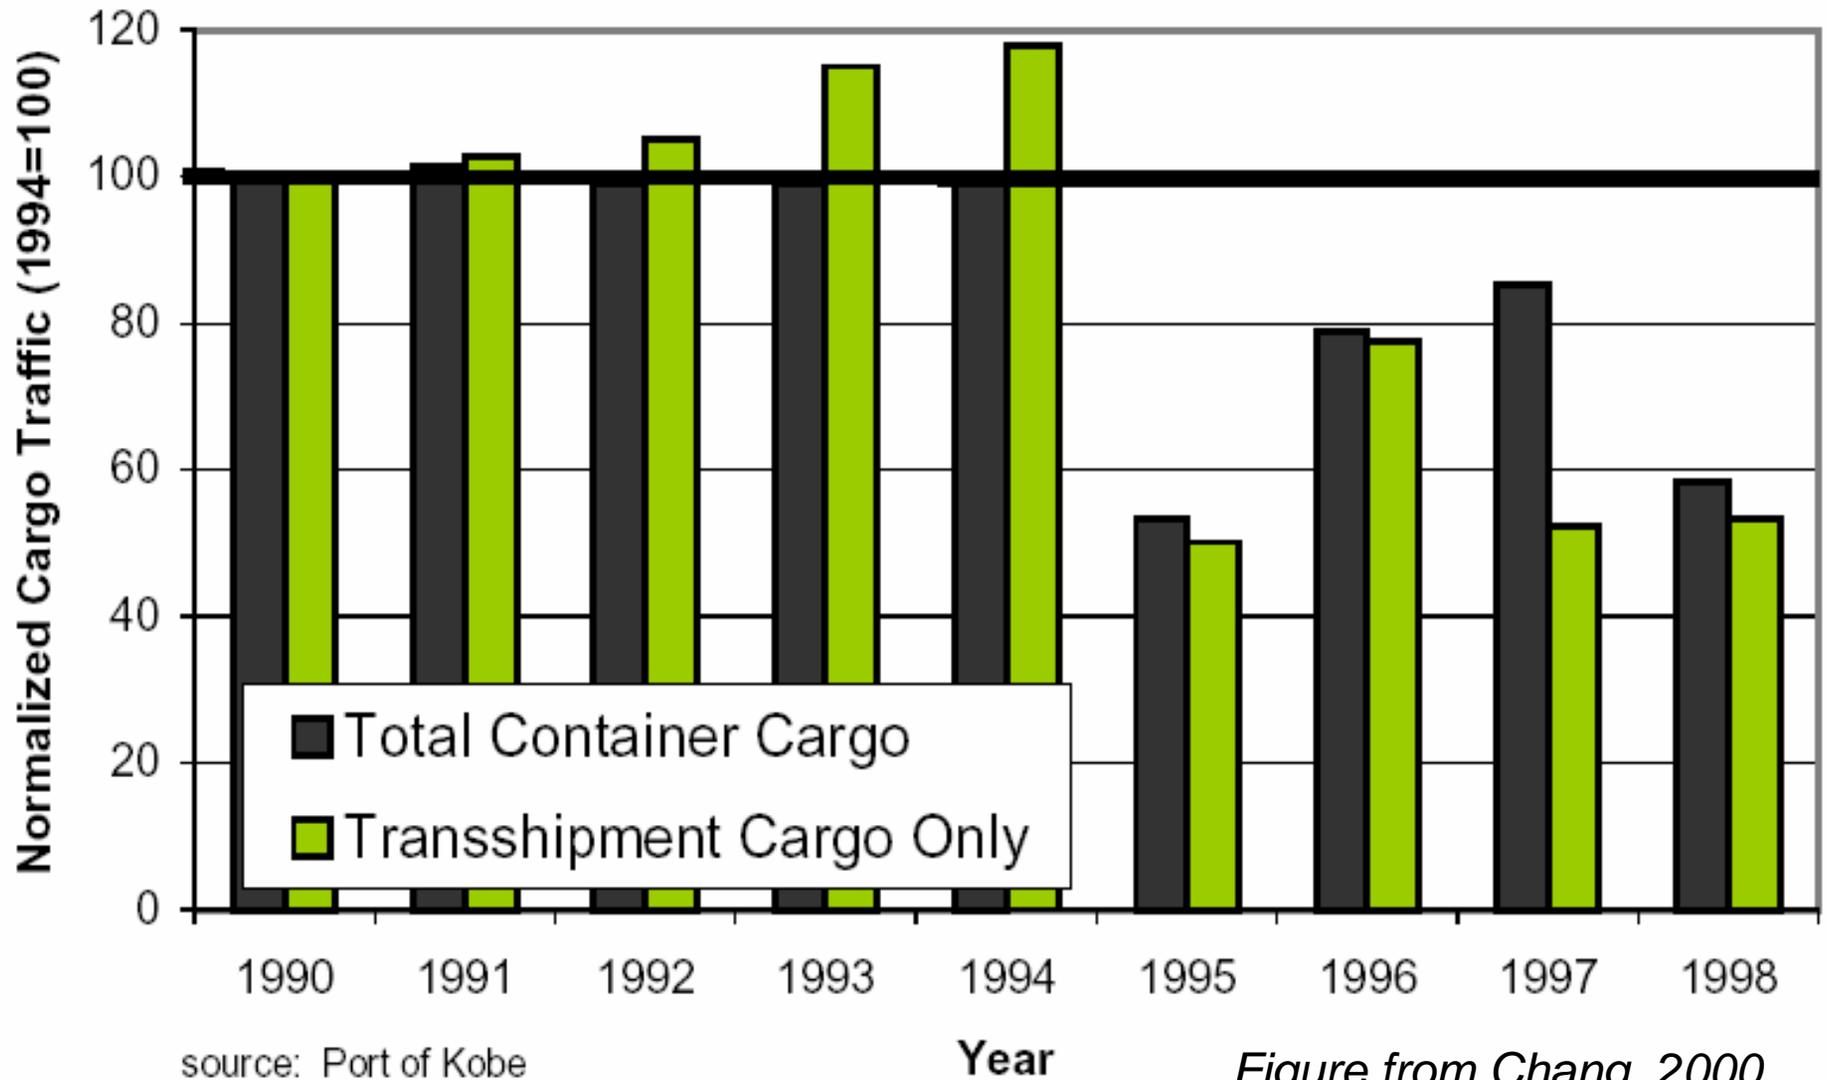
Effect of 1995 Kobe, Japan EQ on Trade at Port of Kobe

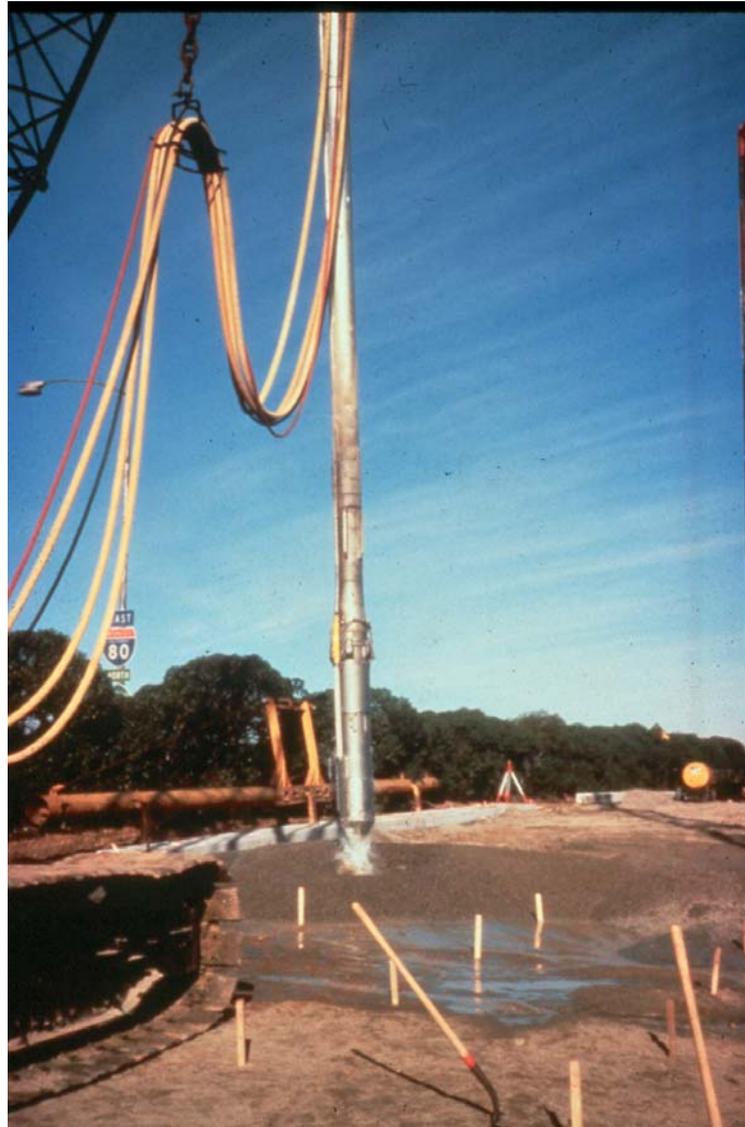
Soil being densified to avoid liquefaction

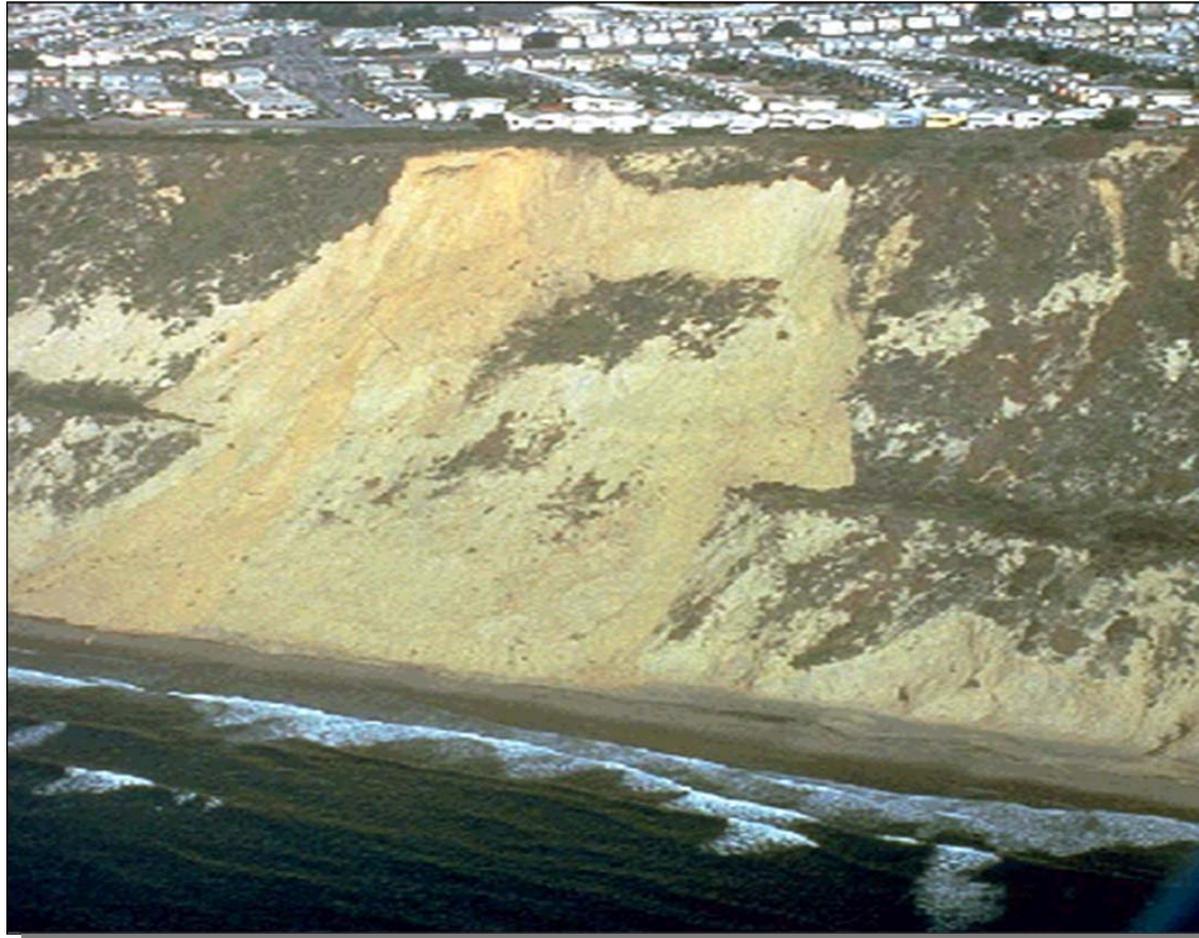
Slope failure during 1989 LPE

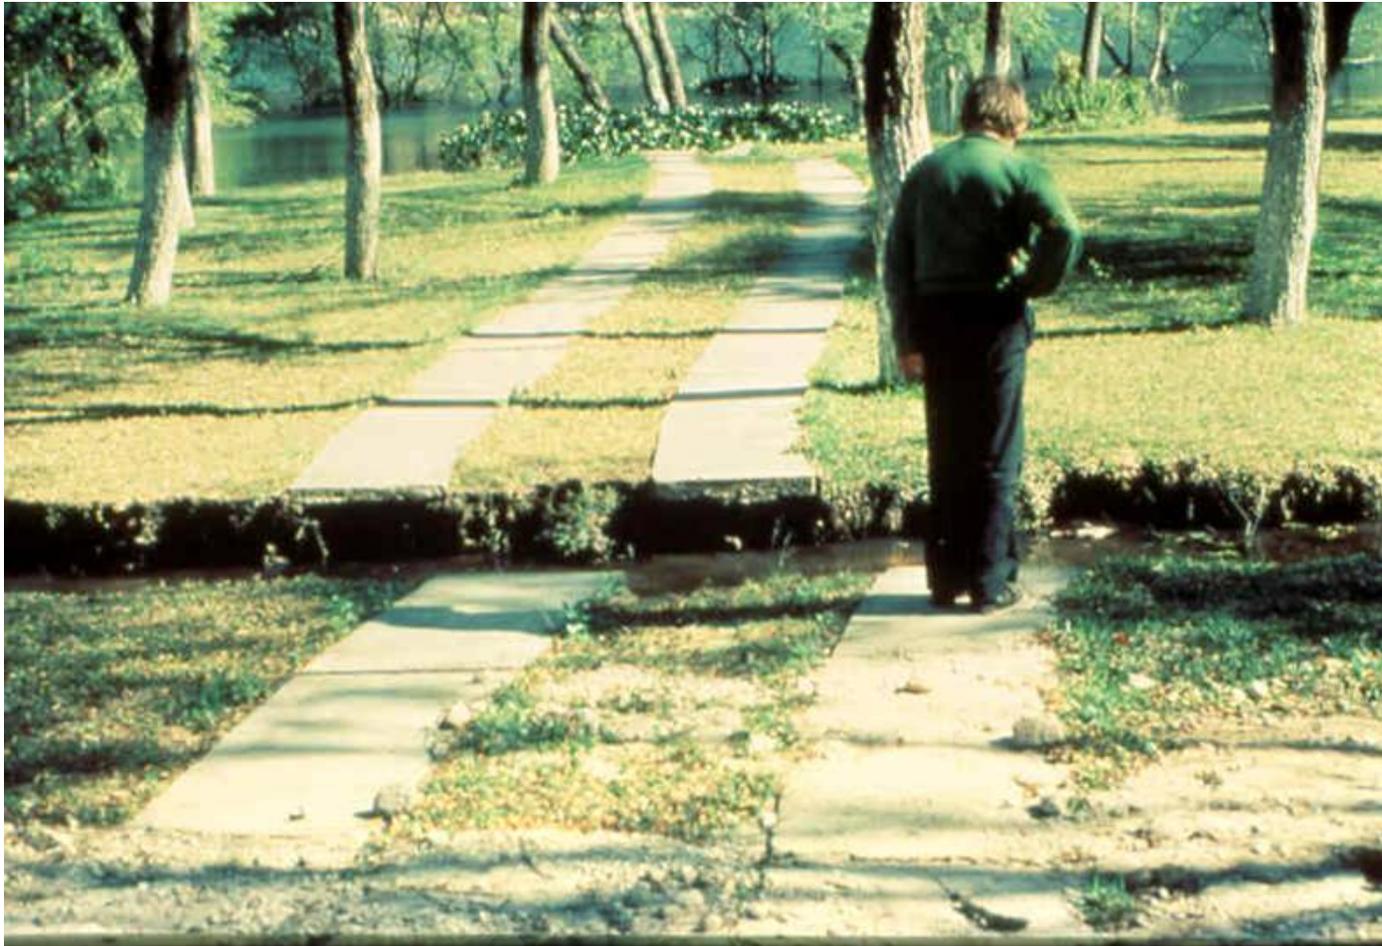
Lateral ground shifting due to fault

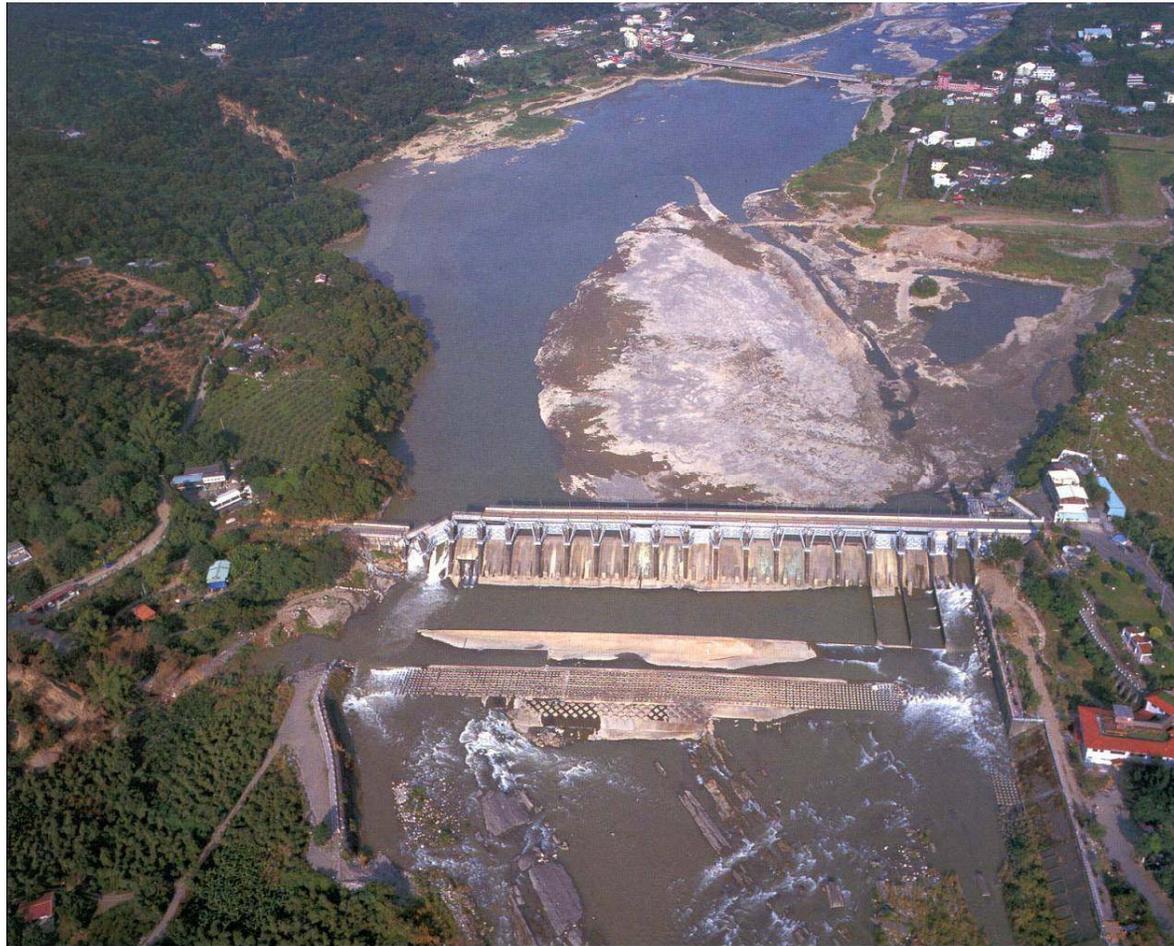
Breach of Dam During 1999 Chi-Chi EQ

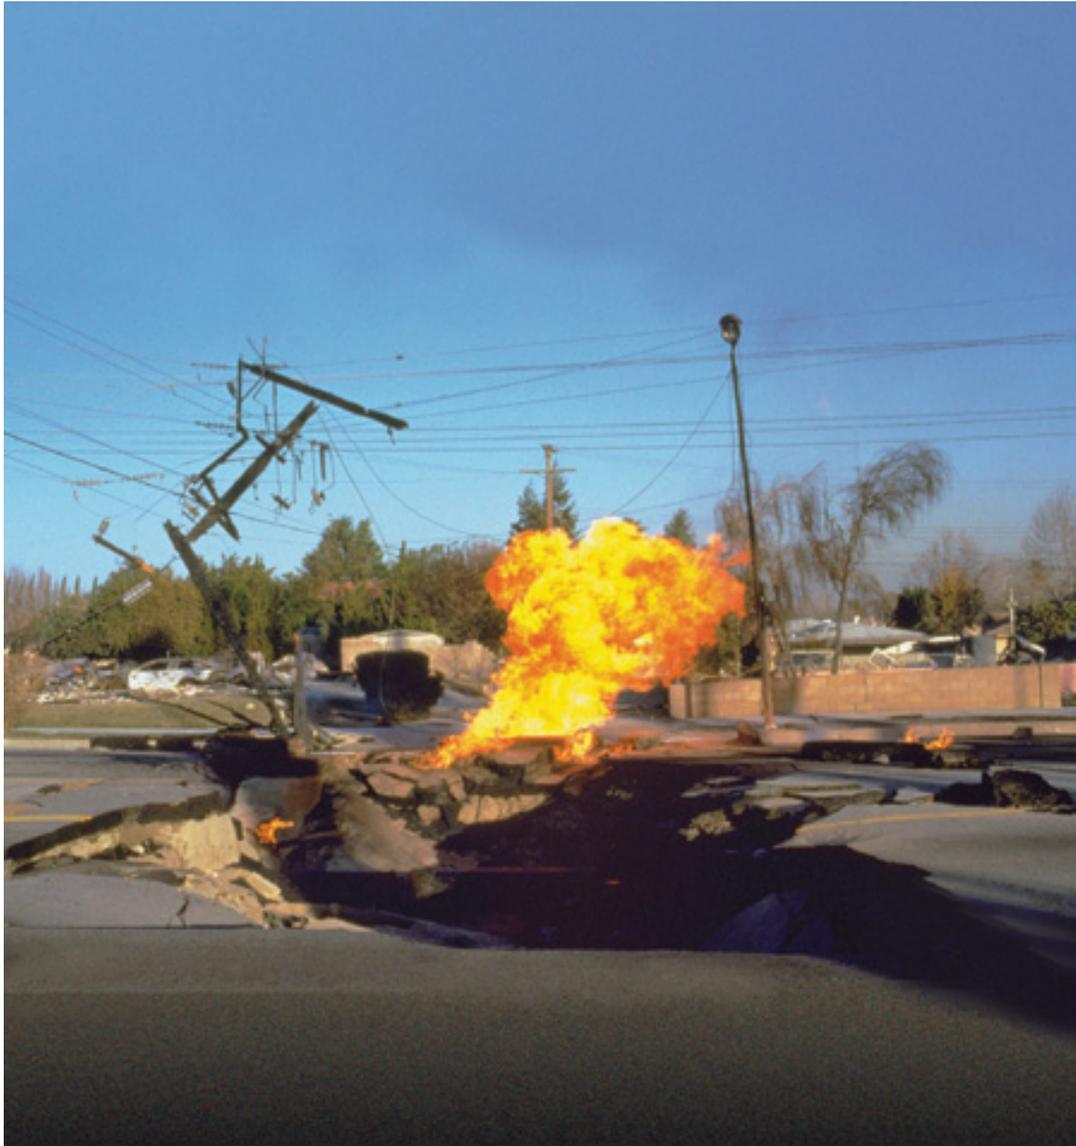
Broken gas line due to ground movements during 1994 Northridge Earthquake

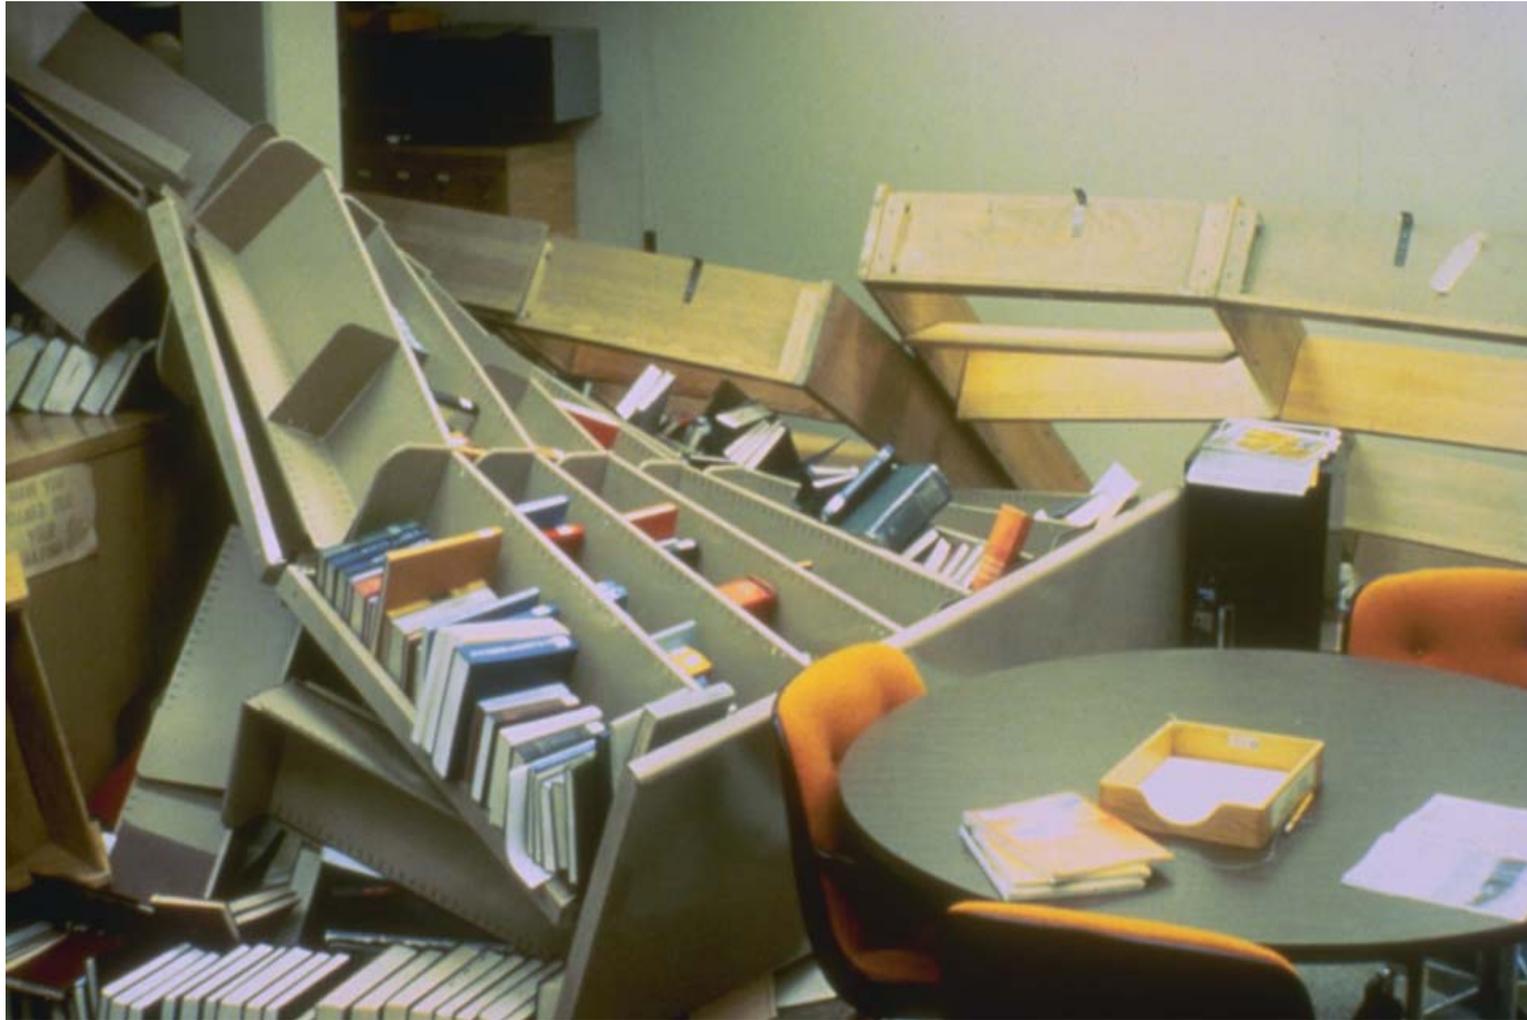
Death or injury can be caused by contents

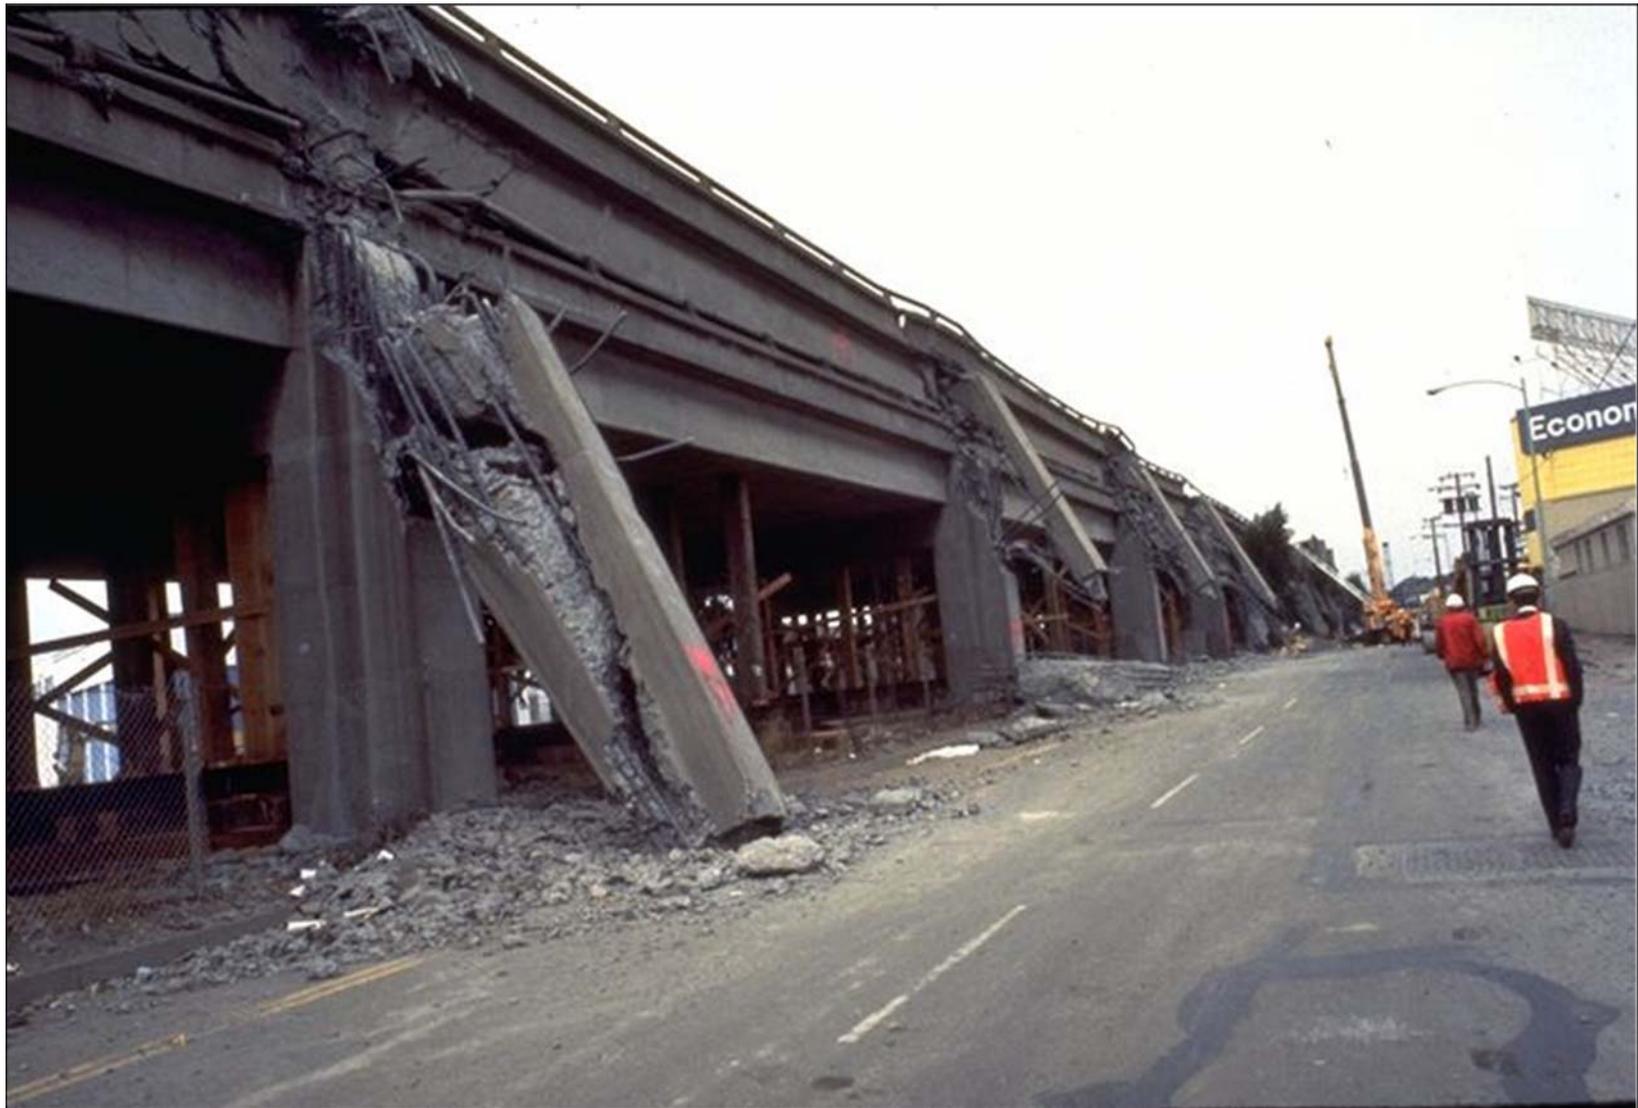
Collapse of Cypress Freeway During 1989 LPE

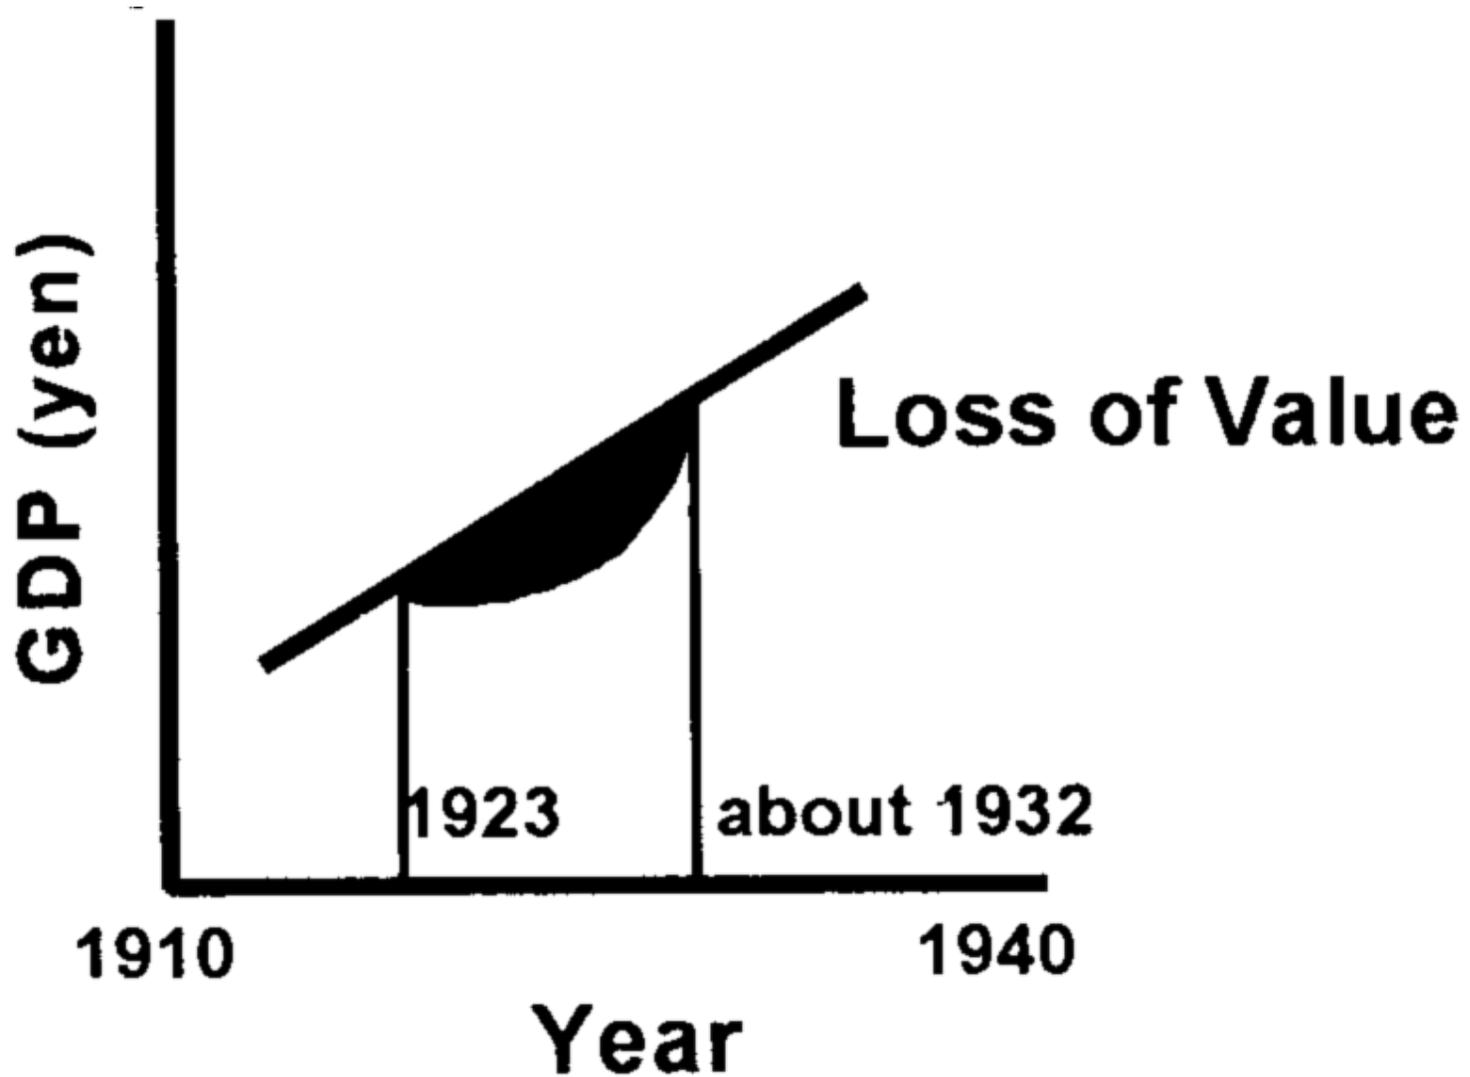
Effect of 1923 Japan EQ on that economy
